Manhole Inspection Summary

Manhole # S29G__040MH

Insp Date: **5/13/09 9:24 PM**

Location Address: **700 W. Fayette St**

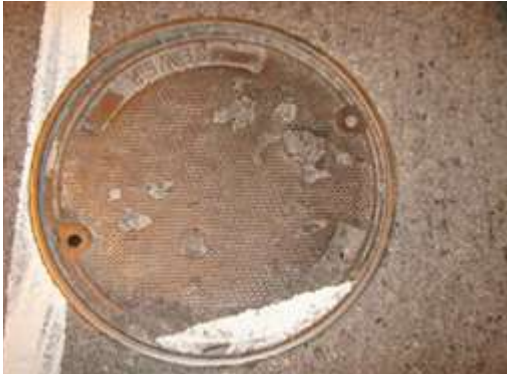
Miscellaneous

mh cover

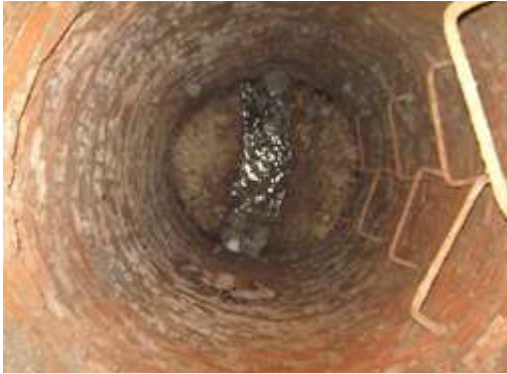
Defect 5

Count: **8** Missing: **0** ☒ **Corroded**

corroded steps

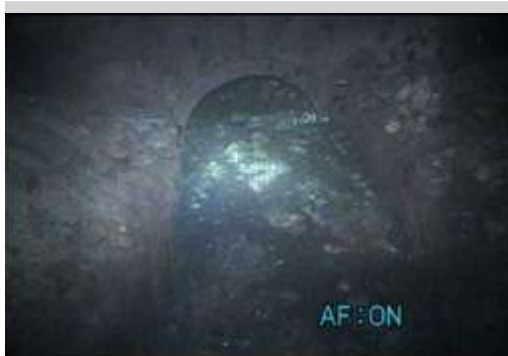
Defect 2

Condition: ☐ Sound ☐ Cracked ☐ Root Intrusion ☐ Deteriorated ☐ Leaks ☒ **Debris**

heavy debris in channel

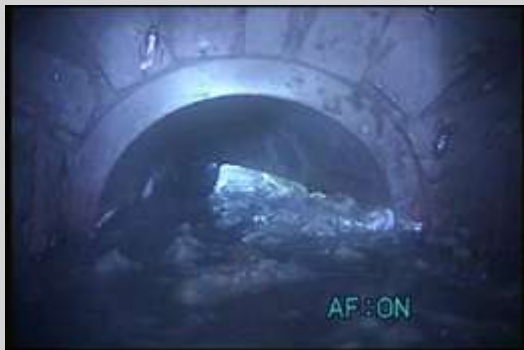
12 O'Clock Outflow

Pipe Height: **9.6** (in.) Rod and Bar (Angled)
Pipe Material: **Clay** ☐ Pipe Lined
Invert Depth: **13.12** (ft.) Flow Characteristics: **Slow**
Deposits: ☐ None ☐ Mud ☐ Sludge ☒ **Debris** ☐ Grease
Silt Depth: **0** (in.) Deposits Extent: **Medium**
Infiltration: **None** Pipe Seal Cond: **Sound**

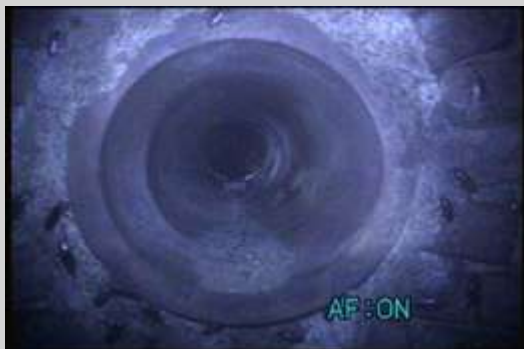
7 O'Clock Inflow

Pipe Height: **10.8** (in.) Rod and Bar (Angled)
Pipe Material: **Clay** ☐ Pipe Lined
Invert Depth: **8.88** (ft.) Flow Characteristics: **Slow**
Deposits: ☒ **None** ☐ Mud ☐ Sludge ☐ Debris ☐ Grease
Silt Depth: **0** (in.) Deposits Extent:
Infiltration: **None** Pipe Seal Cond: **Sound**

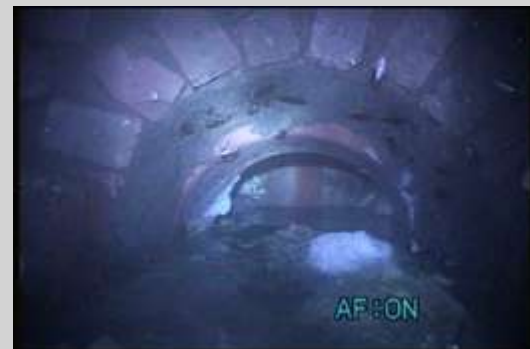
Drop In @ 7 O'Clock

Drop: **Outside** Rod and Bar
Angled: **Yes** Reading: **12.00** (ft.)
Inv Depth: **13.00** (ft.)
Drop Condition: **Open**
